TECHNICAL SERVICE BULLETINS

2/24/89

ERROR CODE INFORMATION FOR ALL SOFTWARE THRU 4.00.00

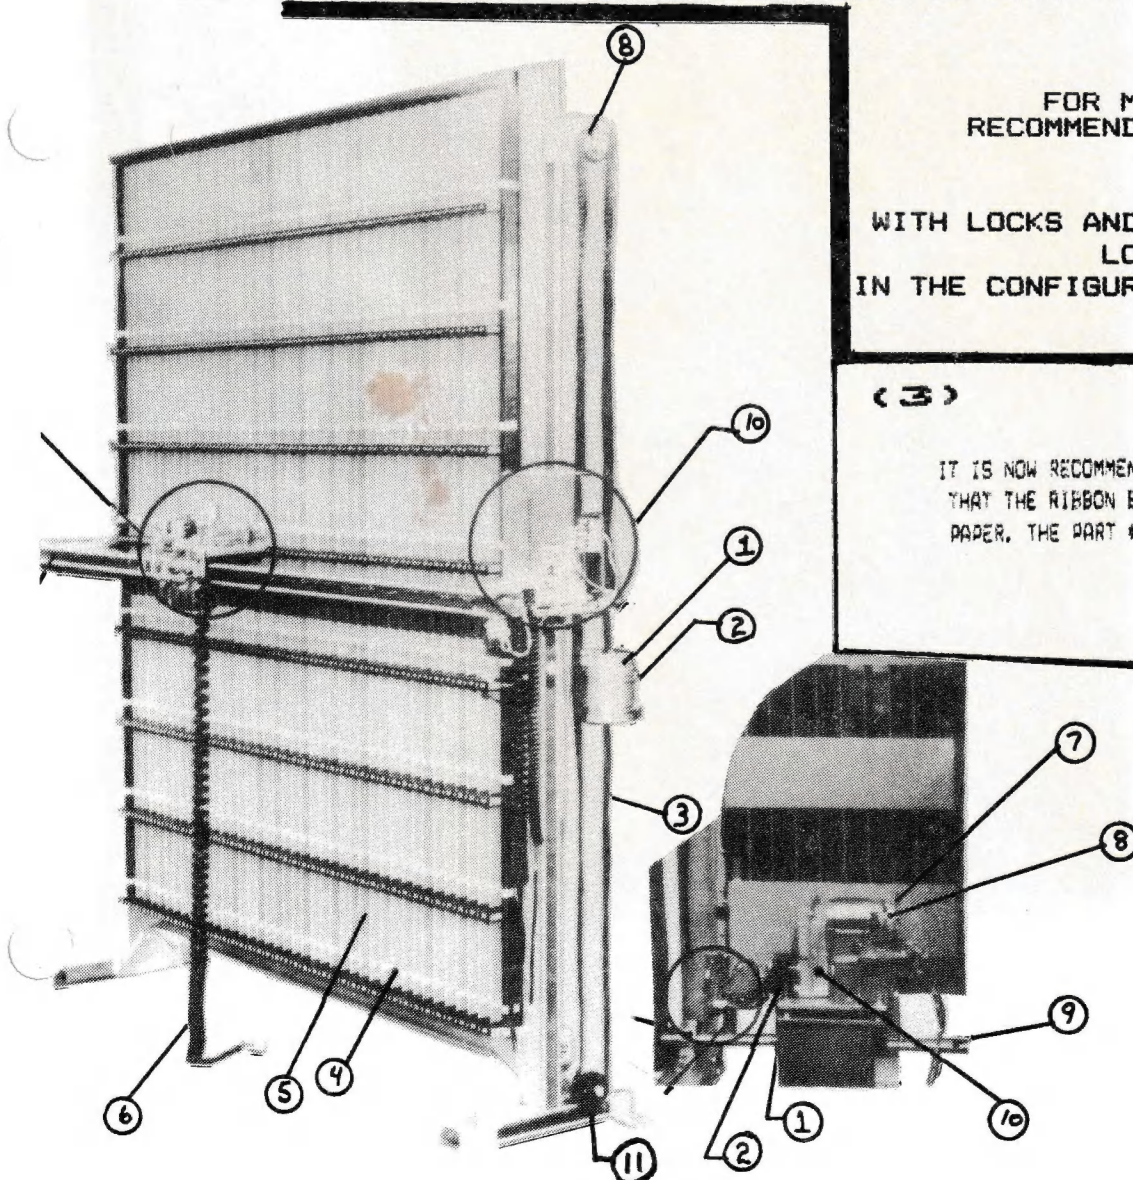
THE SET SCREW MAY COME LOOSE FROM SHIPPING OR OTHER VIBRATIONS ALLOWING THE SPROCKETS TO FALL OFF OF THEIR RESPECTIVE SHAFTS.

SHAFT (9) IS THE SHAFT WITH 3
SPROCKETS ON IT, ONE AT EACH
END AND ONE BY THE MOTOR.
THERE IS ALSO ONE SPROCKET ON
THE MOTOR TO BE CHECKED.

SPECIFICALLY CHECK SPROCKET
PART #'S. (11), (1), (2).

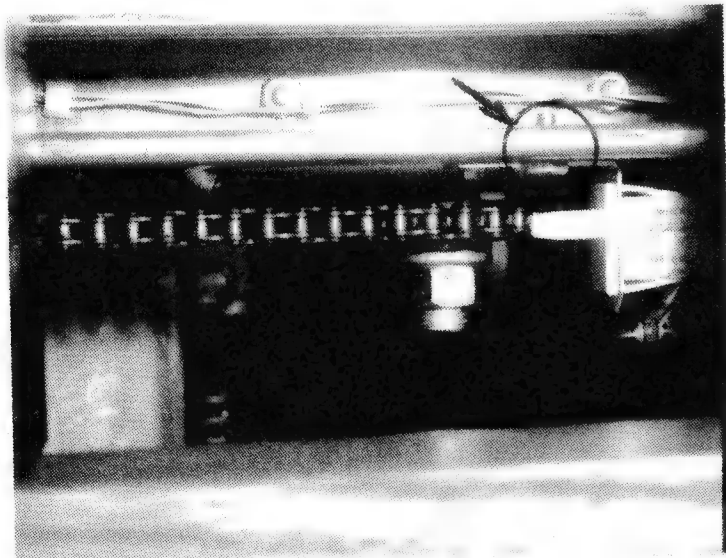
IF THE BOLTS ARE MISSING IT WOULD ALLOW THE TAPE TRANSPORT TO
MOVE TO FAR RIGHT OR LEFT UNDER MANUAL CONTROL OR DURING A
MACHINE MALFUNCTION....SO THAT THE X-ENCODER COULD BE DAMAGED OR
THE OVERTRAVEL LIMIT SWITCHES BROKEN.

HORIZONTAL CARRIER RAISED TO ACCESS
DOOR HEIGHT THIS IS VIEW THRU DOOR.

IF YOUR BOLT AND NUT IS MISSING PLEASE CALL IMMEDIATELY AND WE
WILL SHIP THE CORRECT PART OR ADVISE A LOCAL SUBSTITUTE.

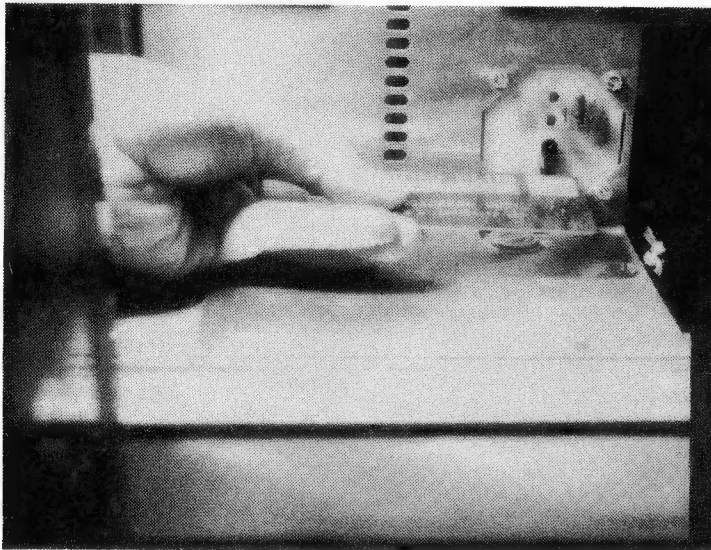
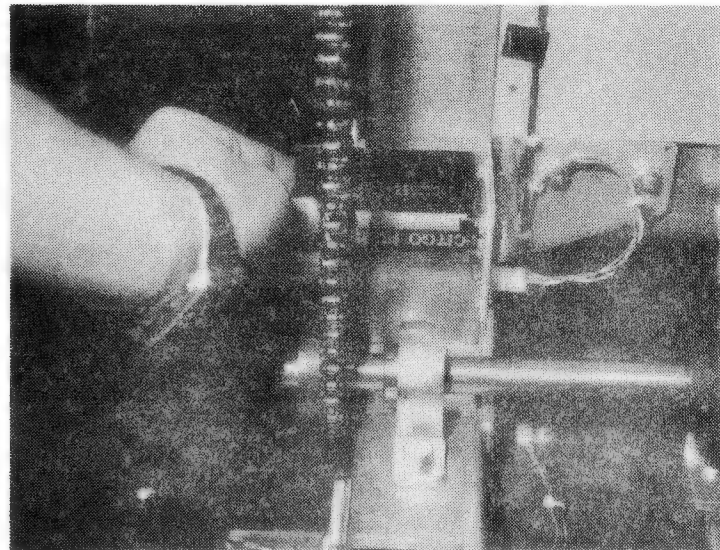
PHOTO (3)

testing x-home

IF THE ENCODERS DO NOT RESPOND TO THE CARD TEST THE PROBLEM COULD BE A DEFECTIVE ENCODER OR A PROBLEM FURTHER DOWN THE LINE TO THE MAIN PROCESSOR BOARD...IN 90% OF THE TIME IT WILL BE THE ENCODER....IF YOU HAVE ANOTHER ONE...ALL ENCODER BOARDS ARE THE SAME PART # MEB 1000 YOU CAN TRY REPLACING THE BOARD AND TEST AGAIN IF THE PROBLEM APPEARS NOT TO BE IN THE ENCODER BOARD THEN SEE PHOTO'S BELOW FOR FURTHER TESTS....

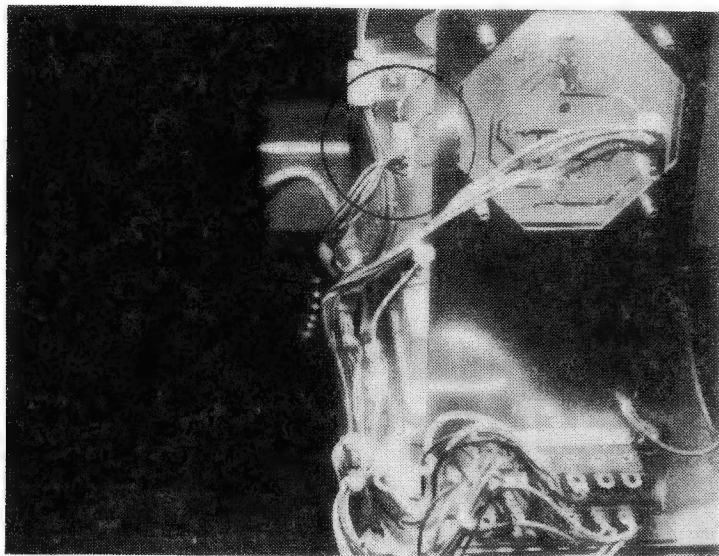
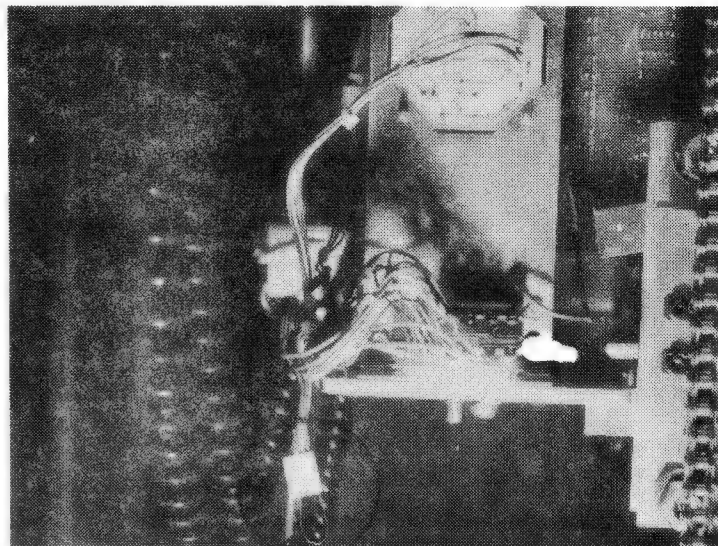
PHOTO (4)

plug in rear of x-home encoder

THIS CONNECTOR HAS 16 PINS. ONE OF THE 16 PINS IS CUT SHORT AND ACTS AS A KEY TO BE SURE THAT THE PLUG CANNOT BE INSERTED WRONG. THE FIRST PIN IS THE GROUND PIN - TO THE GREEN WIRE. THE 8TH PIN- DON'T FORGET TO COUNT THE SHORT PIN- IS THE SIGNAL PIN FOR THE -X HOME. IF THE HOME DISPLAY SHOWS -YES- THEN WHEN YOU PULL THE J4 PLUG THE SCREEN SHOULD SHOW -NO IF IT DOESN'T THE MAIN PROCESSOR BOARD IS DEFECTIVE.

IF THE DISPLAY NOW SHOWS -NO THEN YOU WILL HAVE TO LOOK FOR A SHORT TO GROUND IN THE CABLE SET. IF THE DISPLAY WAS CONTINULY SHOWING -NO THEN TRY SHORTING THE 1ST AND 8TH PINS TOGETHER SEE PHOTO (). THIS SHOULD PRODUCE A -YES- ON THE DISPLAY IF IT DOES THEN THE PROBLEM IS IN THE CABLE YOU WILL HAVE TO LOOK FOR A DEFECTIVE CABLE...BROKEN LEAD OR MORE LIKELY A BAD CONNECTION IN ONE OF THE PLUGS. IF THE DISPLAY STILL DOES NOT SHOW YES THEN THE PROBLEM LIES IN THE MAIN PROCESSOR BOARD.

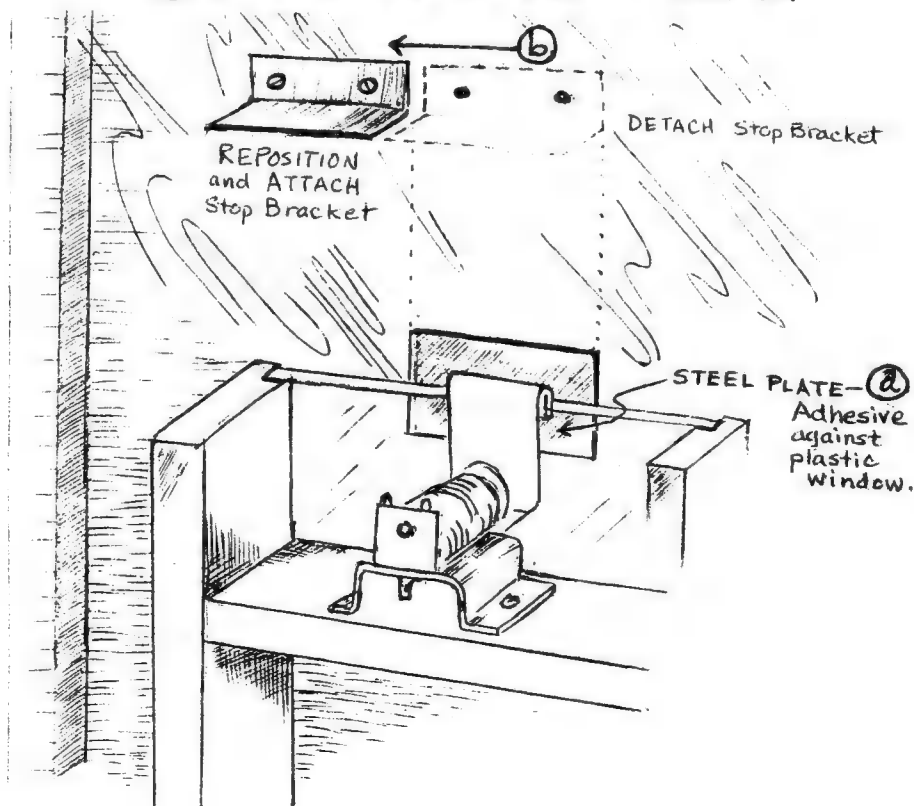
FIG. 1 REAR VIEW OF ACCESS DOOR TOP

1. Open the large lexan door (tape storage compartment) and the large rear door.
2. See FIGURE 1: Rear view of access door top.
3. The enclosed stainless steel plate has a special high strength adhesive applied to the lower half of one side. (Be careful, due to its thinness the steel plate has sharp edges.)

4. Peel off the adhesive protective paper and insert the plate between the plastic access door and the cabinet wall, adhesive side toward the plastic door, centered on the latch. See FIG. 1a. Position the plate so that the adhesive layer is just below the top of the plastic door and is approximately level. Now press the plastic door against the steel plate. Hold firmly for five seconds.

5. Remove the two screws from the upper stop bracket. Move bracket towards the command center (tv screen). Position it to clear the new protector plate. (Remember, the door has some slide or twist play--make sure to allow for this movement.) Secure bracket with the two screws. See FIG. 1b.

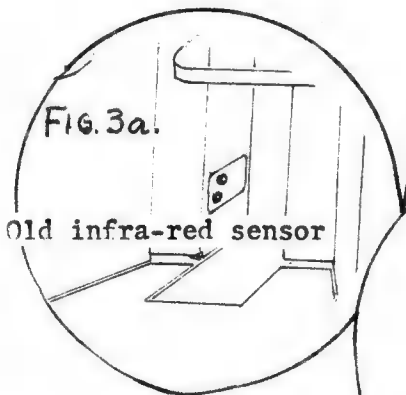
FIG. 3a.

Old infra-red sensor

Either the mechanical sensor or the infra-red solid state sensor with the LEDs in the position shown in 3a (closest to the lexan doors), should be replaced with the newest version of the tape top sensor. It has LED (light emitting diode) sensors in the position shown in 3b (closest to the tape shelves).

To determine if you have this type of sensor, look into the rectangular window, FIG 2b. If the LEDs are angled and positioned toward the rear of the slot (lexan door side) as in FIG. 3a, you do. These infra-red switches will now be replaced at no charge. The LEDs on the new board are positioned toward the tape shelves as in FIG. 3b, where they always look at the front edge of both VHS and Beta tapes. No soldering or cable changes are necessary.

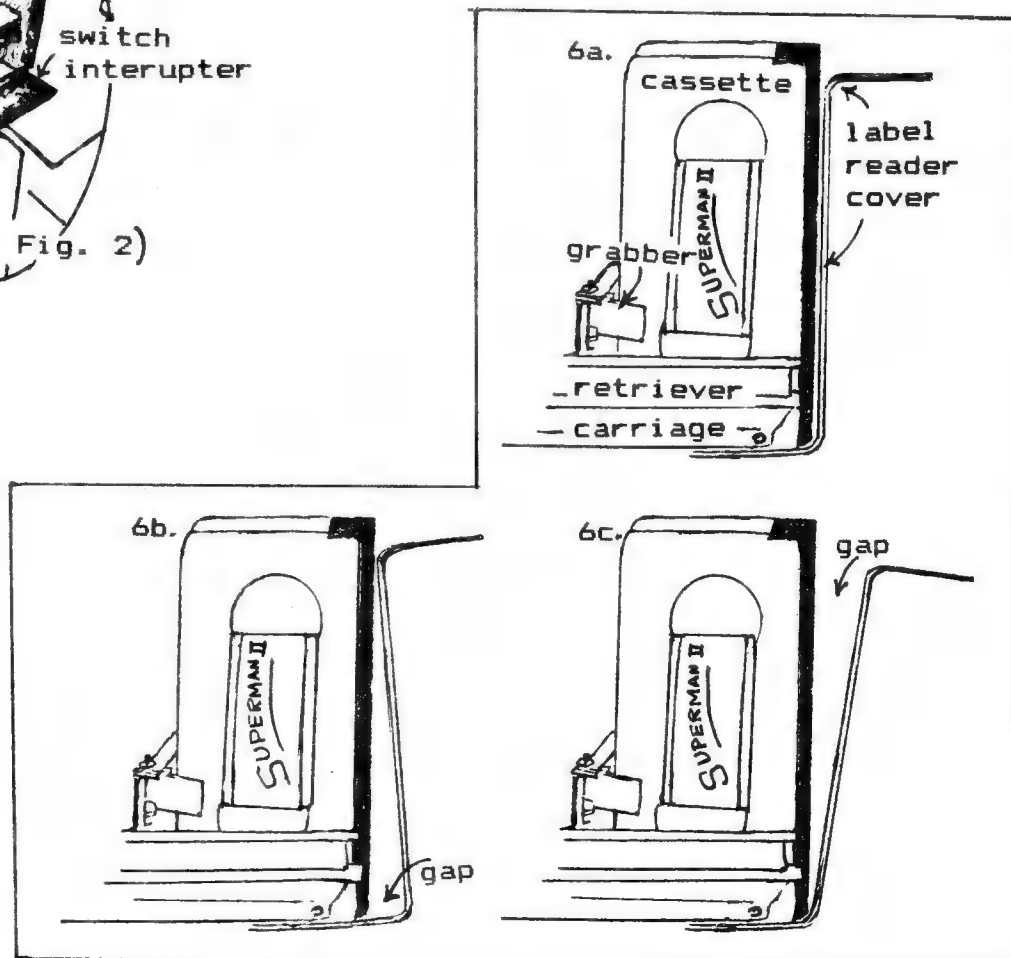
FIG. 6

3. Correct tape cassette alignment to the label reader cover is shown in Fig. 6a. The cassette must be pushed flush against the label reader cover. The alignment in 6b is incorrect but the machine can still work because the grabber, positioned low on the tape, will continue to push the tape flush to the label reader cover. To remove the gap, however; open the access door, reach in and PUSH the top of the label reader cover to the position shown in 6a. The alignment in 6c is incorrect and the machine will probably work intermittently because a gap between the top of the cassette and the label reader cover cannot be closed by the grabber. To correct this; open the access door, reach in and PULL the top of the label reader cover to the position shown in Fig. 6a. (You must overcompensate while pushing or pulling the cover in order to bend it sufficiently to remain in the correct position.)

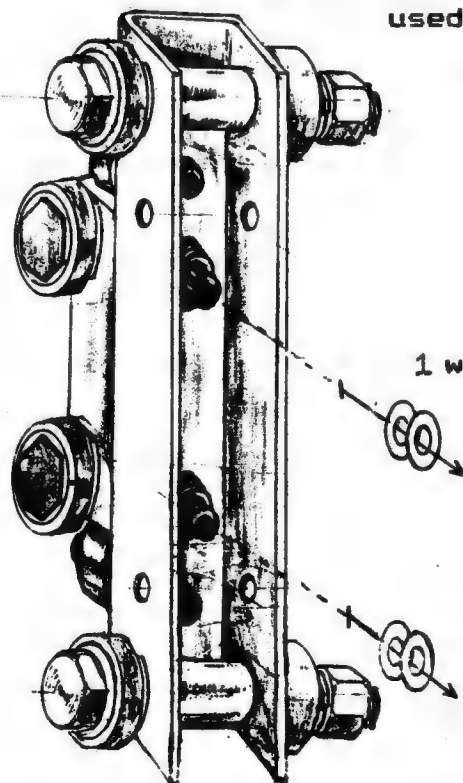
FIG. 3

NOTE: Belleville spring washers are
used in pair configurations.

7. Removing one screw at a time, leave ten spring washers (5 pair) under each of the two screws. See FIG. 3.

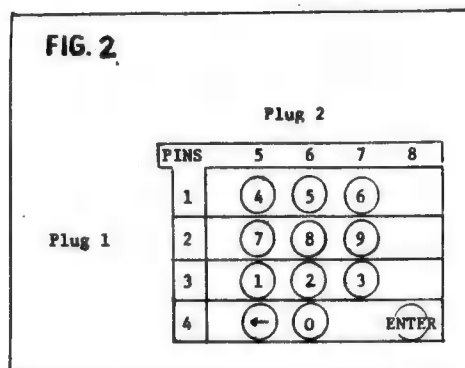
Fig. 2 is a matrix of the pins as they correspond to the Key Pad keys. Fig. 3 is the chart of outputs for checking continuity when a key is being depressed. All tests on the key pad should be made statically with the power to the machine shut off. The continuity checks are made with an OHM meter connected between the pins indicated in Fig. 3's chart. For each Key on the Keypad depressed you should read continuity on the OHM meter between the keys indicated. If no continuity is measured the Keypad is bad and should be replaced.

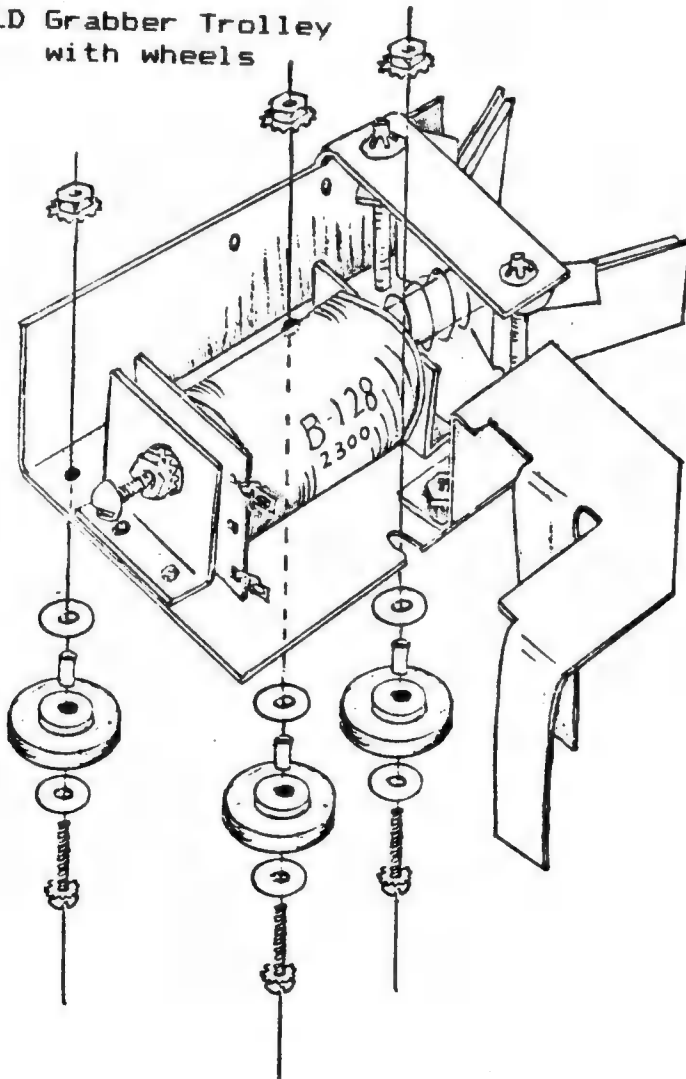
OLD Grabber Trolley
with wheels

The new Slide Glide eliminates the wheels and their associated maintenance. It is a direct and easy replacement as illustrated in the self-explanatory diagrams below. The Slide Glide Kit #K1A-2592 is available at \$ 7.00 and includes spacers and glide plate.

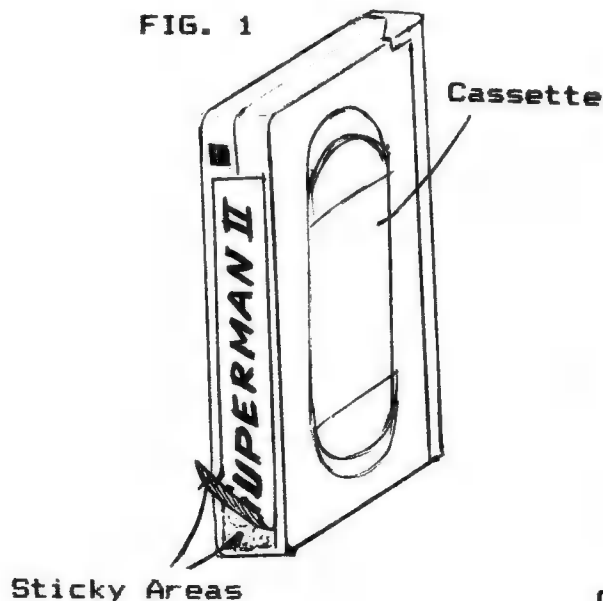
FIG. 1

We have noticed that the Title Labels on the spines of cassettes can begin to peel up (See FIG. 1) and can cause retriever "Error 99" problems.

The corrective action is to inspect your tape inventory and replace all stickers or Title Labels that appear loose before they become a problem.

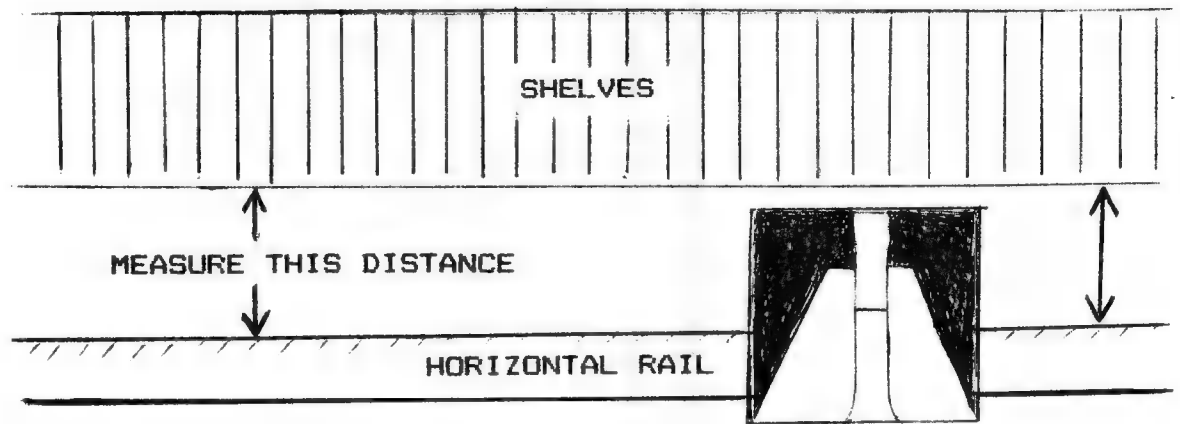
FIG. 1

The "Grabber In" switch can only be adjusted properly in only ONE place in the machine. That is the shelf location where the horizontal beam is at the closest distance to a shelf (See FIG. 1). You will have to move the bar in front of all eight shelves and measure each to find the location where the bar is closest to a shelf. Once you have found the closest point, that will be the location where you will adjust the "grabber in" micro-switch.

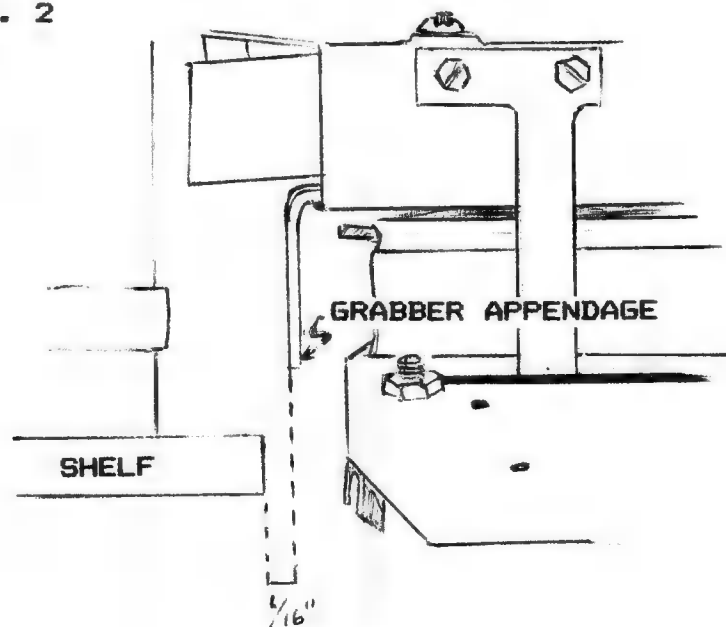
FIG. 2

Run the grabber in toward the shelf. It should be stopped by the "Grabber In" microswitch about 1/16" before the grabber appendage hits the shelf. If it stops too soon or if it hits the shelf, adjust the "Grabber In" microswitch. To do this, loosen the two screws (See FIG. 3) holding the switch bracket and move the bracket to the proper position to achieve the 1/16" gap. See FIG. 2. Tighten the screws and retest the grabber action.

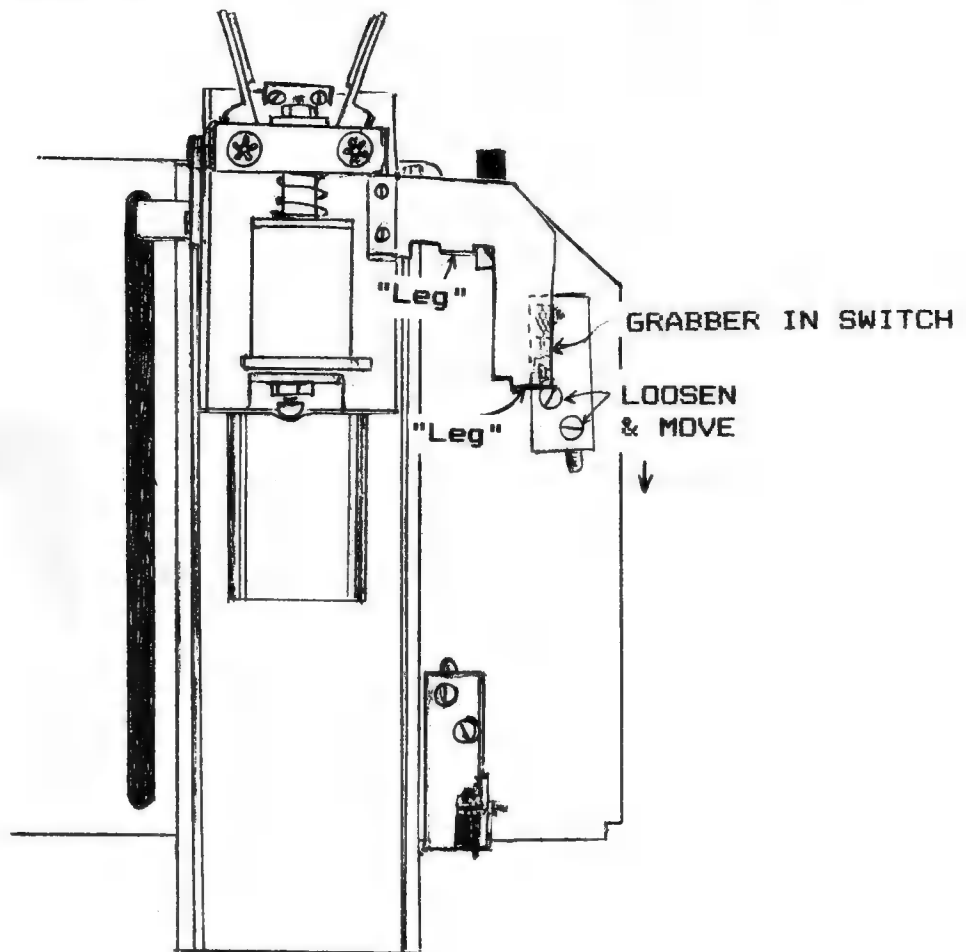
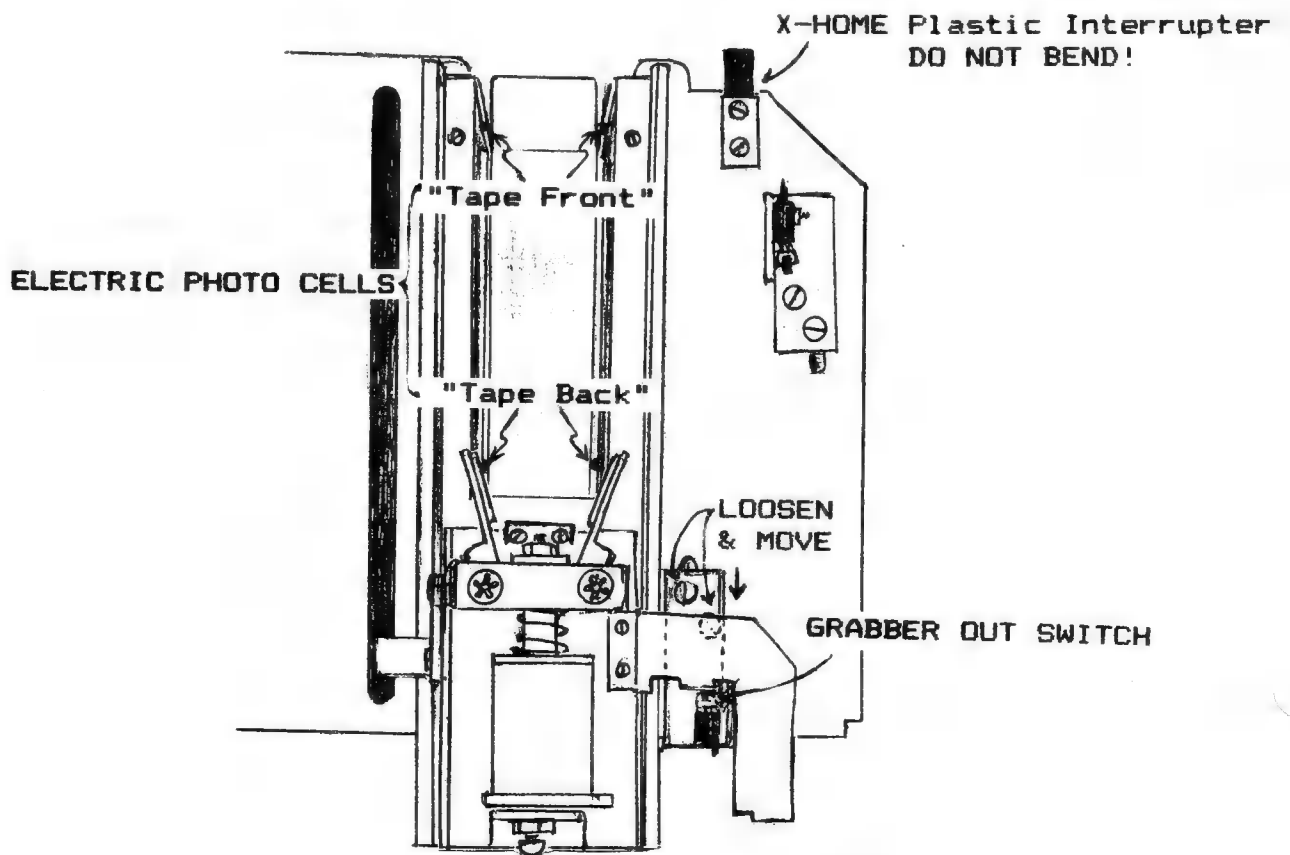
The grabber "In" and "Out" switches are located inside the Retriever's stainless steel, box shaped housing. To uncover the grabber switches, you must first move the retriever to a convenient location in the machine. To do this, open the top service door and enter Feature #19, Diagnostics. Run the retriever up to location #150. Open the Lexan doors. Remove the four screws from the sides of the retriever cover (two on each side). Turn OFF the AC power. Carefully, lift off the cover and note how the wires are tucked under the Z Motor housing. Unplug (by pulling apart) the white connector on the wires between the retriever and its cover. You can now completely separate the retriever cover from the retriever mechanism which will expose the grabber "In" and "Out" switches. See FIG. 3 & 4.

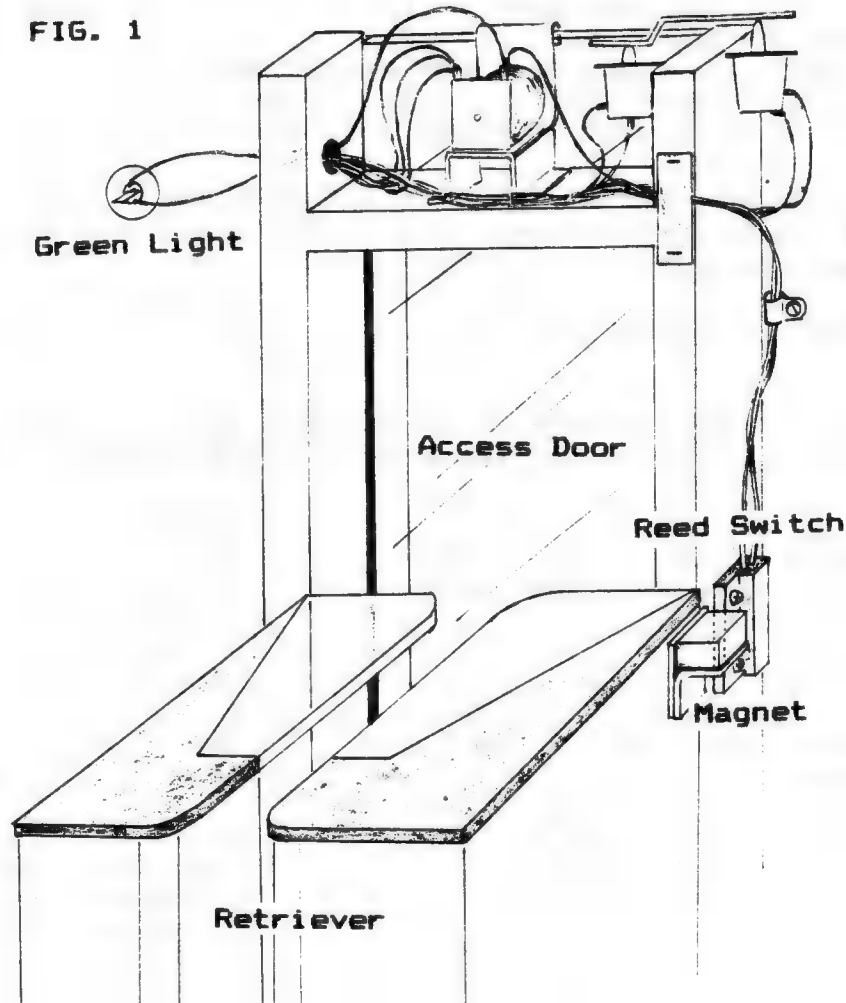
FIG. 1

c) The magnet is aligned but the reed switch is burned out.

Short the 2 wires on the reed switch together eliminating the switch from the circuit. If the machine works properly replace the reed switch.

Check the output of J3 Pin 6 to see if it goes to ground potential when the access door is activated with the "door" button on the MCB. If it does not, replace the Motor Control board.

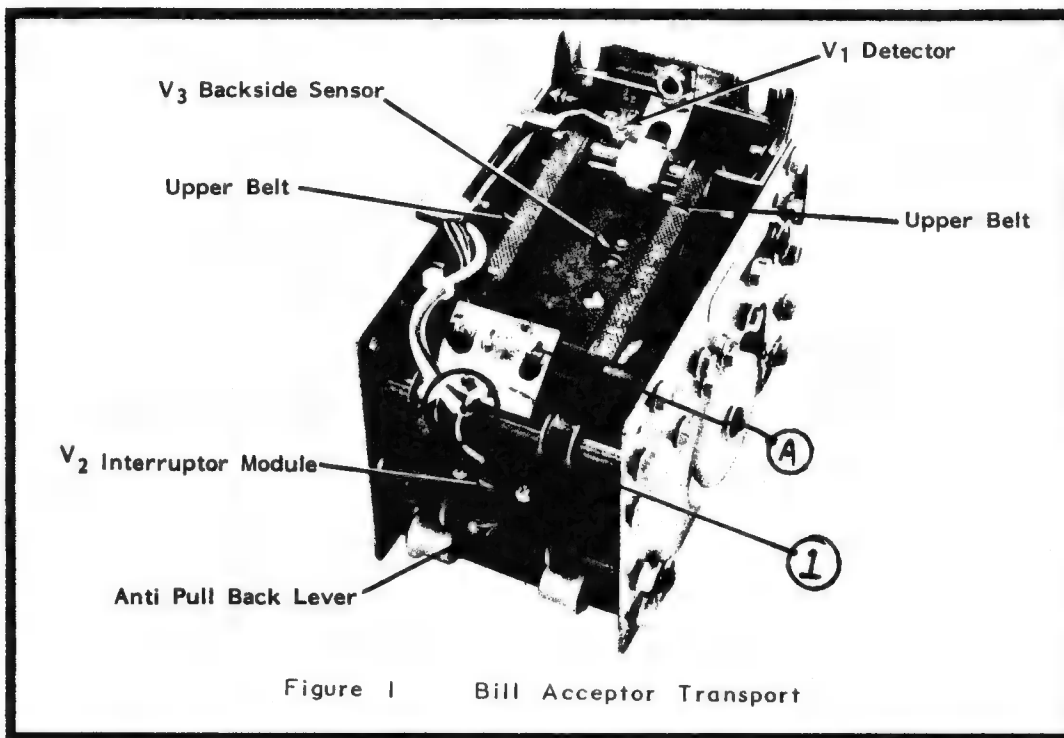
Figure 1 Bill Acceptor Transport

SUBJECT: DOLLAR BILL VALIDATOR REFUSING TO ACCEPT ANY BILLS.

#1 POINTS TO THE SHIELDED GREY COVERED TWO WIRE CORD.

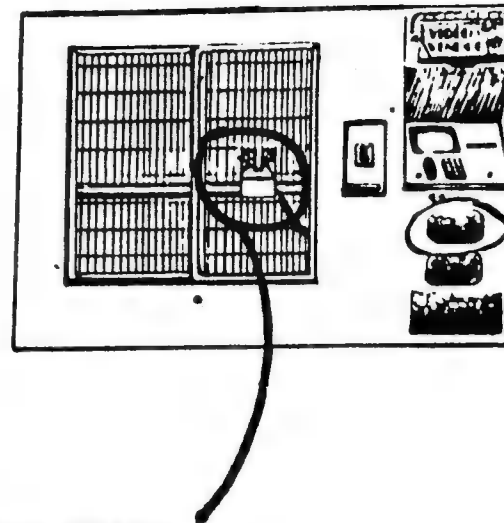
PREMATURE FAILURE OF THE TAPE TOP CIRCUIT BOARD

IF THE ELECTRICAL INSULATING TAPE COVERING THE SIX PIN TERMINAL STRIP TB#2 SHOULD COME OFF, IT IS POSSIBLE FOR THE TRANSPORT COVER TO CAUSE 28 VOLTS TO BE PUT ON THE TAPE TOP CIRCUIT BOARD. THIS WILL CAUSE PREMATURE FAILURE OF THE BOARD.

THE SOLUTION TO THIS PROBLEM IS TO CHECK THIS TERMINAL BOARD AND INSTALL THE ELECTRICAL INSULATION TAPE IF IT IS MISSING.

IF TAPE PROTECTION IS MISSING
PUT PLASTIC ELECTRICAL
TAPE OVER THESE TERMINALS
TO PREVENT CONTACT WITH
THE STAINLESS STEEL COVER.

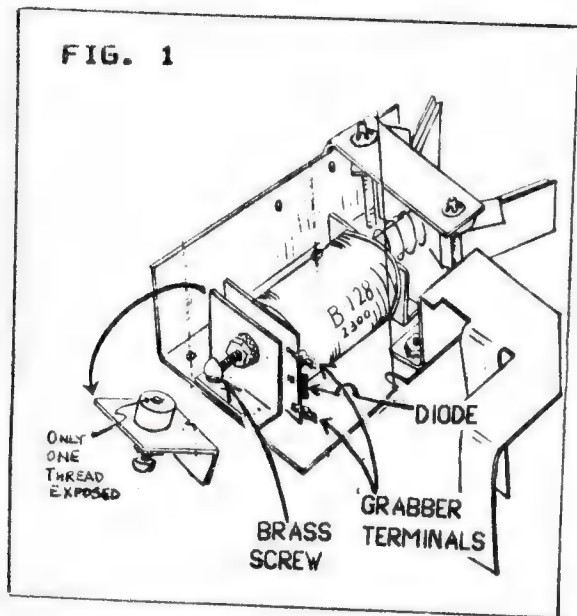
FIG. 1

| 1. GRABBER FAILS TO CLOSE. | <ul style="list-style-type: none">(A) NO VOLTAGE AT GRABBER TERMINALS. SHOULD BE AT LEAST 19 VOLTS. (FIG. 1)(B) CHECK DIODE ACROSS GRABBER TERMINAL FOR SHORT. PARTICULARLY IF YOU BLOW THE FUSE WHEN THE GRABBER CLOSSES. (FIG. 2)(C) CHECK FOR BROKEN GRABBER WIRE. (USUALLY AT THE POINT WHERE WIRE GOES TO SOLENOID COIL OF GRABBER.)(D) CHECK FOR DEFECTIVE GRABBER SOLENOID OR MCB 1000 BOARD. VOLTAGE AT J3 PIN 10 SHOULD BE 29 VOLTS WHEN GRABBER IS OPEN AND 0 VOLT WHEN GRABBER IS CLOSED. SEE BULLETIN 13 FOR MEASUREMENTS.(E) CHECK THAT GRABBER TERMINALS ARE NOT TOUCHING ANY METAL SURFACE. (FIG. 1) |

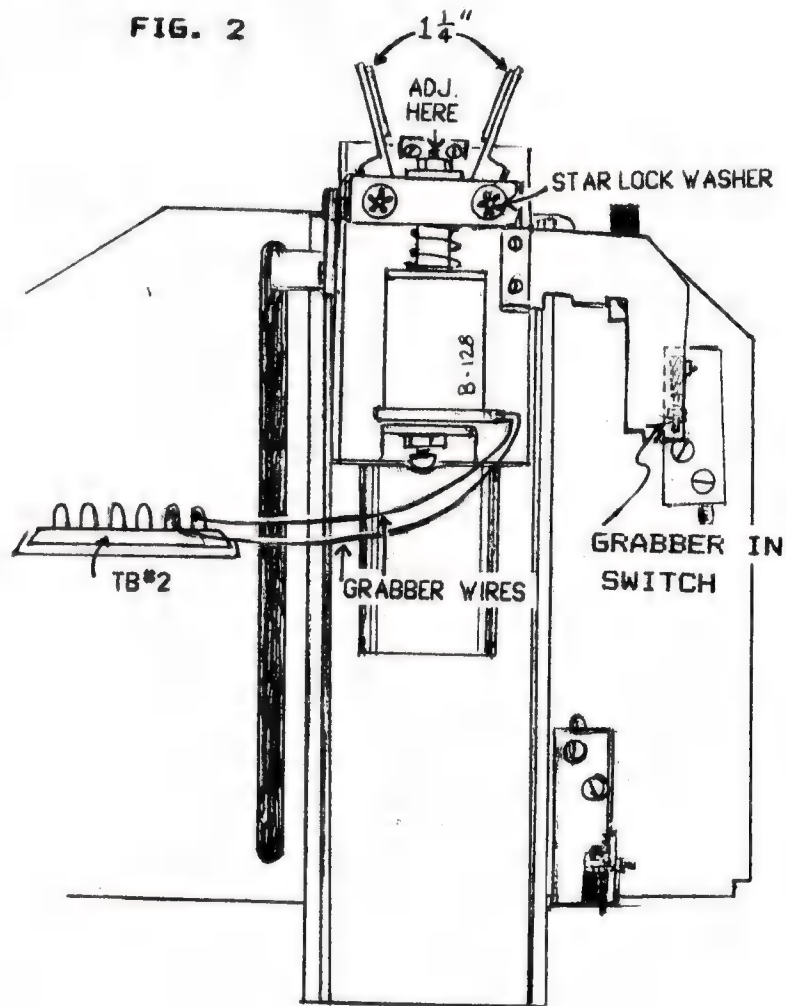
FIG. 2

| 2. CASSETTE SLIDES OUT OF GRABBERS GRIP. | <ul style="list-style-type: none">(A) CLEAN GRABBER PADS WITH DENATURED ALCOHOL SOLUTION OR REPLACE GRABBER PAD IF WORN.(B) CHECK GAP BETWEEN GRABBER PADS. IT SHOULD BE 1 1/4". (FIG. 2)(C) CHECK BRASS SCREW (MAGNETIC BRAKE) ONLY ONE THREAD SHOULD BE SHOWING ON INSIDE OF THE SOLENOID TUBE. (FIG. 1) |

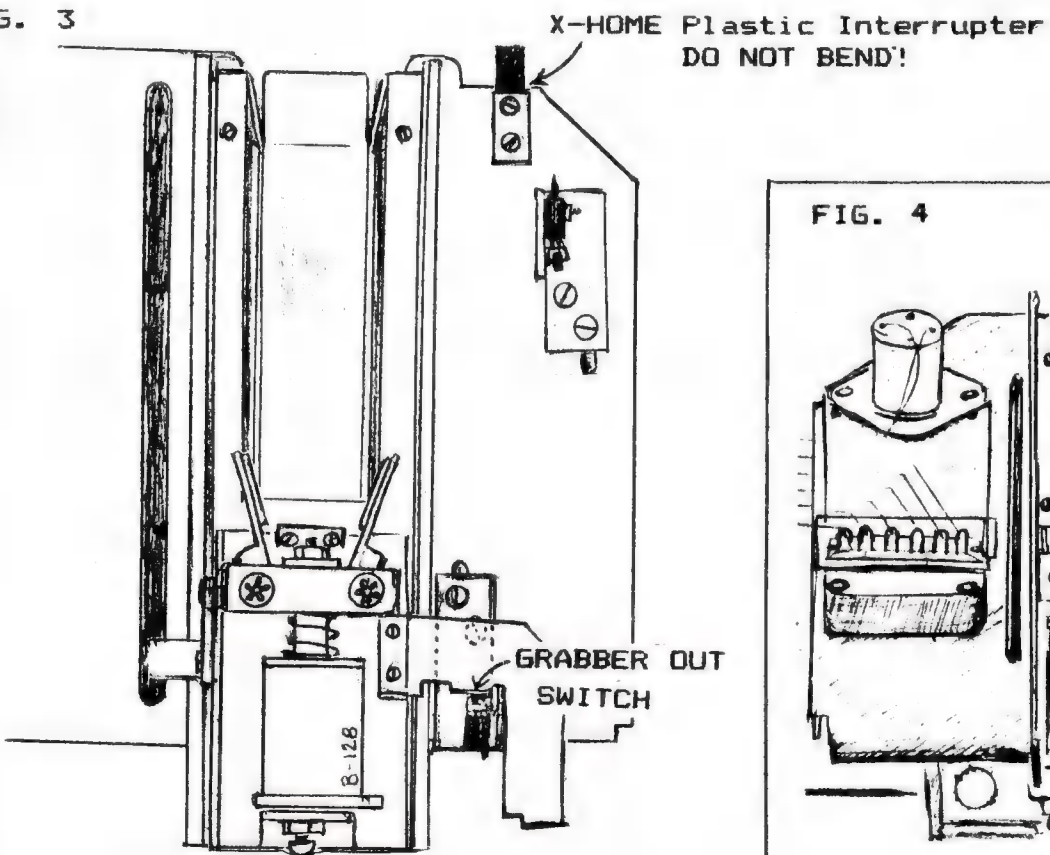
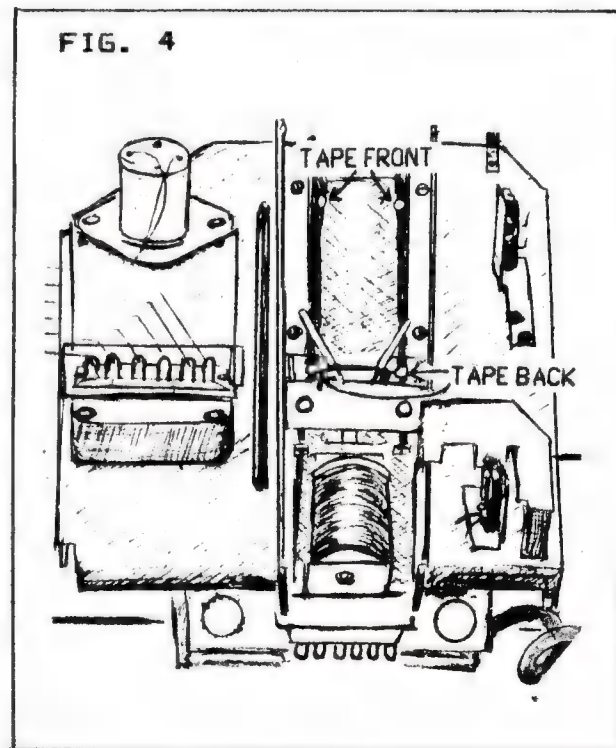
(D) GRABBER OUT SWITCH IS NOT WORKING AND "Z" MOTOR IS TRYING TO PULL THE GRABBER OUT AGAINST REAR STOP. (FIG. 3) REPLACE SWITCH.
8. GRABBER DOESN'T MOVE AND Z MOTOR DOESN'T RUN. (A) "Z" MOTOR BAD. (FIG. 4) CHECK VOLTAGE ACROSS MOTOR TERMINALS. IT ALTERNATES DEPENDING ON DIRECTION. SEE BULLETIN 13A.

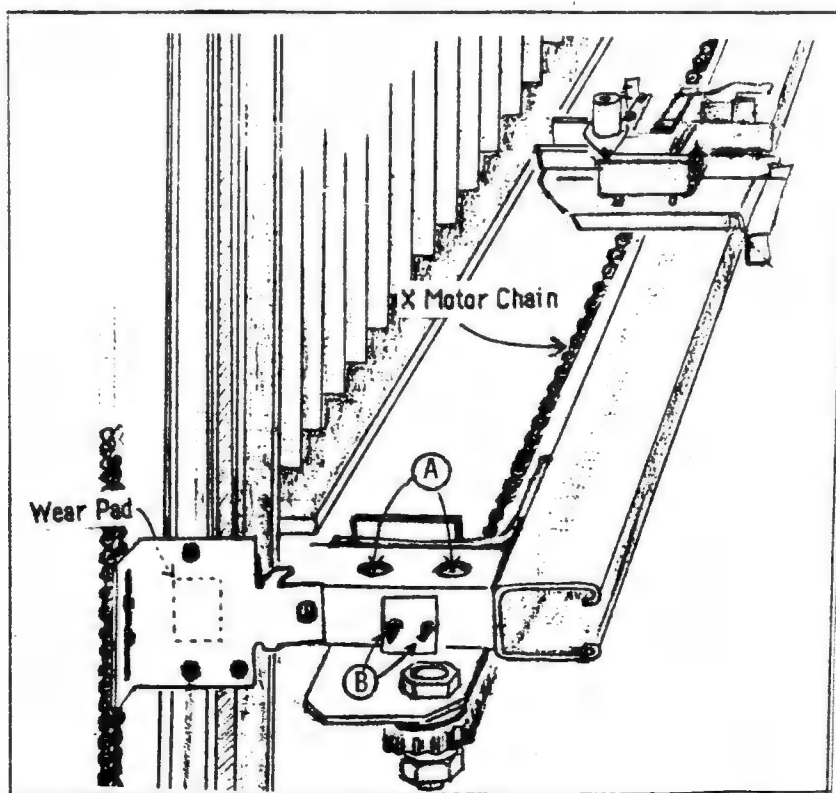
In both of these cases, if the retriever moves or if the chain hangs down too much; the repair is to tighten the chain.

Loosen the locking nut located through holes at point "A". Then, to tighten the chain, tighten the nuts at point "B". Or, to loosen the chain, loosen the nuts at point "B".

When finished lock down the nuts located through holes at point "A".

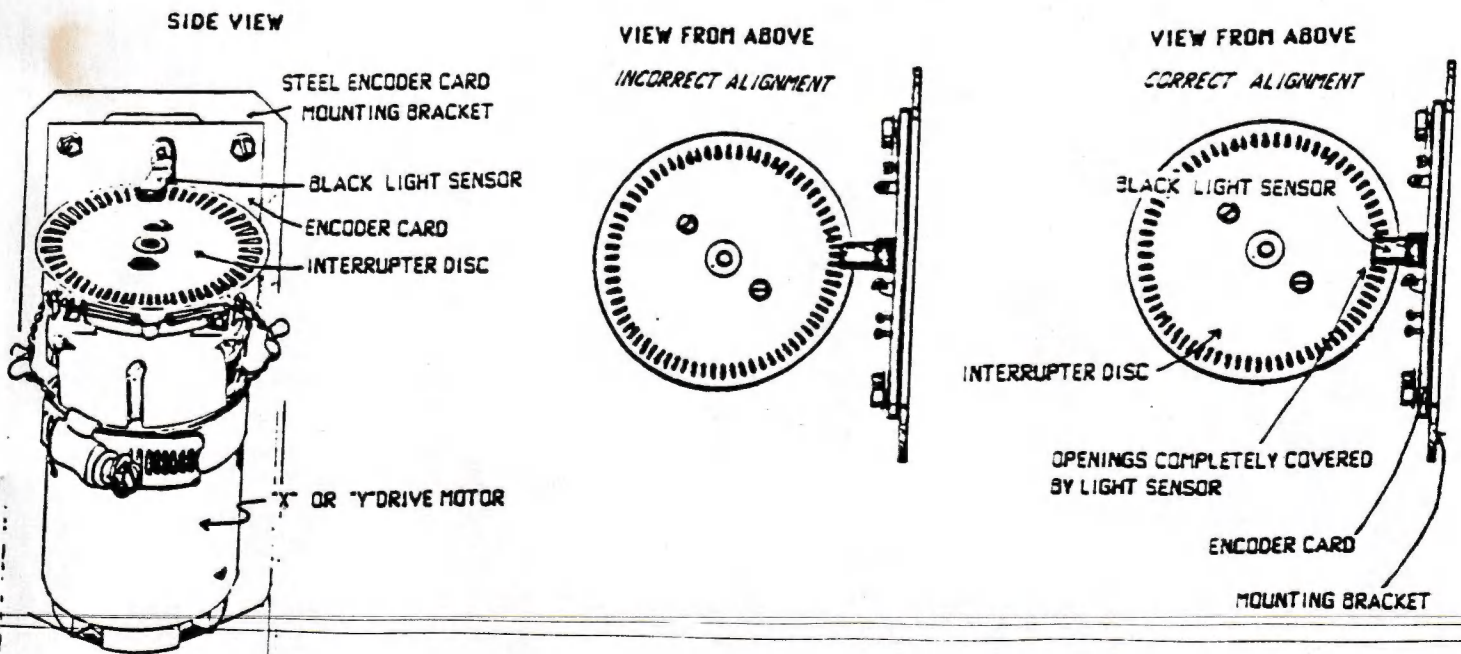
The cause is that the encoder does not read all the light pulses and allows the motor to send the mechanism further in order read the required number of pulses for a given location. If the openings of the interrupter disc are not completely covered by the sensor, counts (light pulses) are being missed and extra ones added.

Although the above represents the majority of faults regarding this problem, it is possible that you may have a faulty encoder card or a bad connection.

NOTE: This is NOT the problem if the retriever consistently arrives SHORT of the intended location.

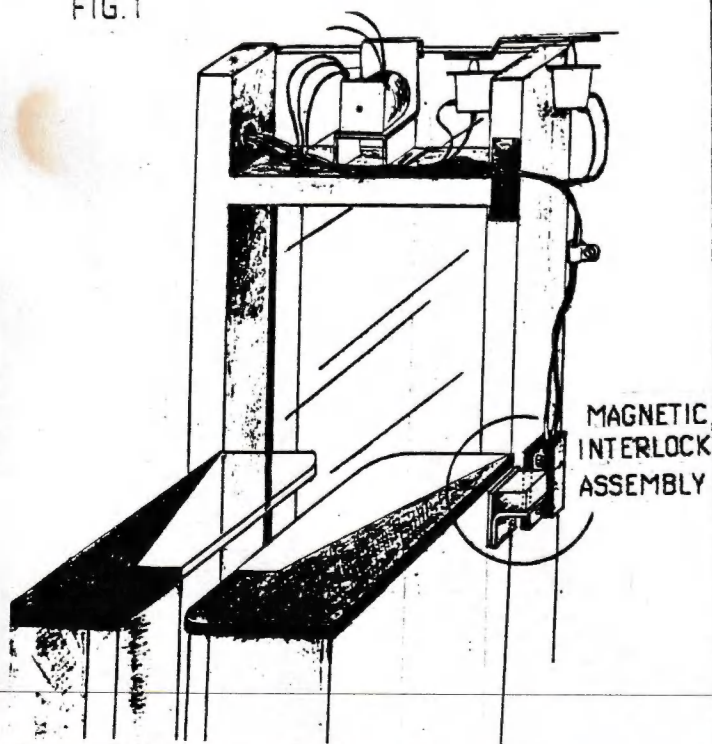
FIG. 1

Test: using the keypad in Diagnostics, Feature 19; raise the transport assembly so it is level to the access door in its normal delivery position and so that the magnetic interlock assembly (Fig. 1) is aligned. Pressing the "1" key should activate the door latch and green light allowing the door to be raised.

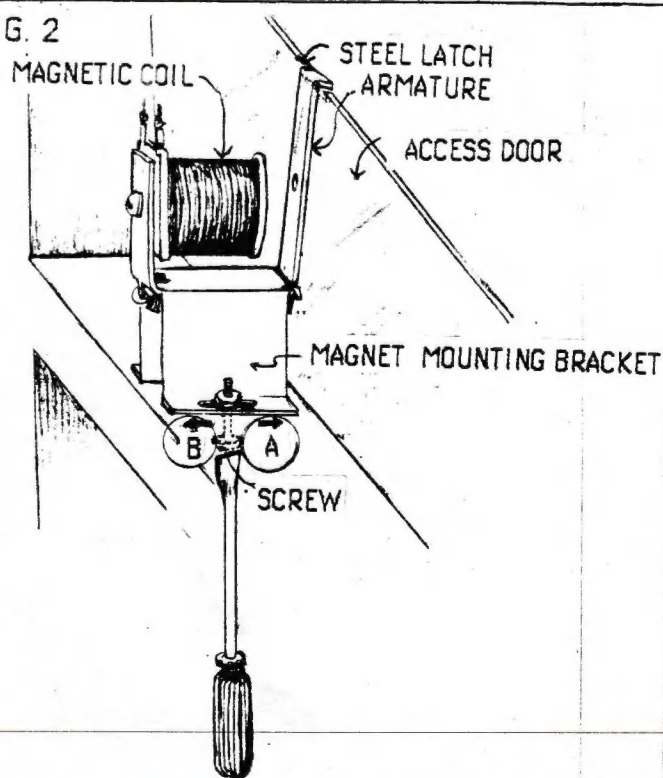
FIG. 2

If the magnet is too close to the armature, it will pull but not draw the latch far enough to allow the door to open. You will need to loosen the two screws and slide the bracket $1/32"$ to $1/16"$ away from the armature (Fig. 2, arrow B). Retighten screws and check operation.

To do this, loosen the two screws (one on each leg) of the magnet mounting bracket (see Fig. 2). Slide the bracket $1/32"$ to $1/16"$ towards the armature (Fig. 2, arrow A). Retighten the screws and check operation to be sure you did not position the magnet **too close** to the armature. This would cause the door latch to be unable to clear the top of the door, also resulting in the access door not opening with the green light lit.

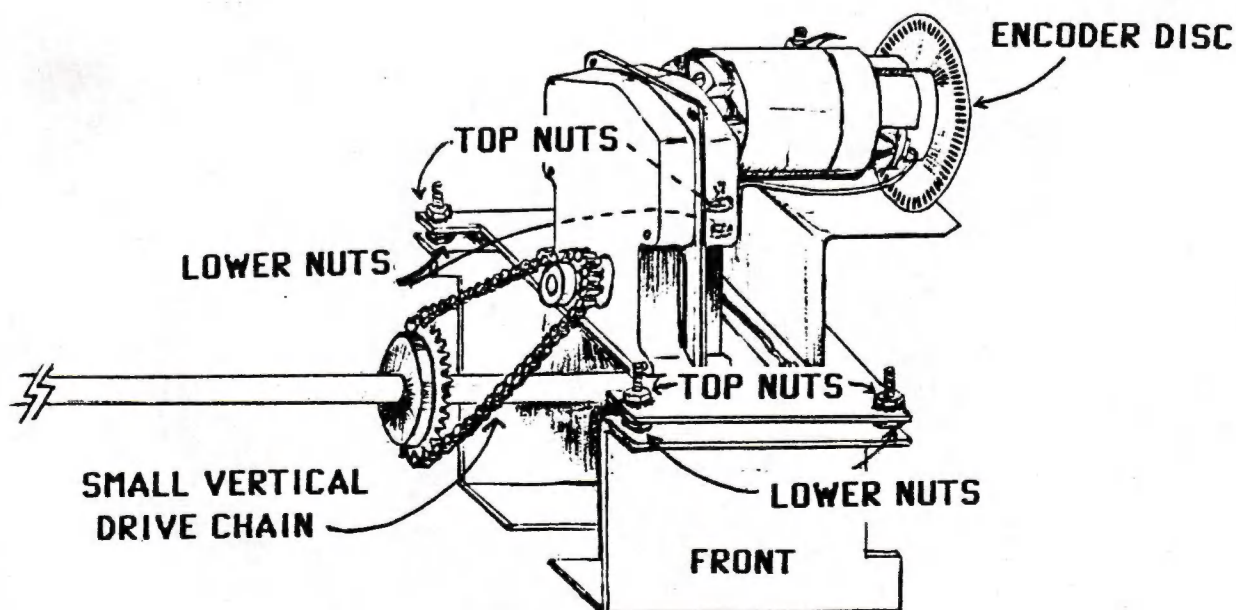
ADJUSTING VERTICAL DRIVE CHAIN TENSION

PROBLEM: If you notice that when renting a movie from locations below the access door, slots 200 - 320, the transport mechanism aligns correctly with the door entry. When renting from locations **above** the access door, 1 - 120, however, the mechanism does not line up with the access door and can be off by $1/4"$ - $1/2"$. The probable reason for this is that the vertical drive chain is too loose, so that when the motor reverses to bring the mechanism back, pulses (counts) are lost due to more chain looseness than was originally compensated for by the software.

TEST: Manually turn the encoder disc (See Diagram) until the chain begins to move. Stop and turn the disc in the opposite direction. If you can rotate the disc **more** than $1/2$ turn, the chain needs to be tightened.

ADJUSTMENT: Loosen the top nuts shown in the diagram. (If only a slight adjustment is needed, only the front ones need loosening, otherwise loosen all four top nuts.) Screw the lower nuts upward making gradual adjustments until the chain moves by turning the encoder disc a $1/4$ - $1/2$ rotation in the opposite direction. Don't forget to retighten the top locking nuts.
